VitaTech Engineering, LLC

Subject: Letter Report - New Jersey Stray Voltage/Ground Current Investigation & Final Assessment

VitaTech was recently tasked by NRRI to investigate reported “stray voltage” problems in a neighborhood adjacent to the Herbertsville Substation operated by Jersey Central Power & Light (JCP&L) in the Town of Brick, New Jersey. The objectives of this letter report, which is not a detailed engineering study, are to present the salient information obtained from VitaTech’s investigation and to offer a final assessment with recommendations to mitigate the “stray voltage” problem in the Brick neighborhood and nearby Herbertsville Substation.

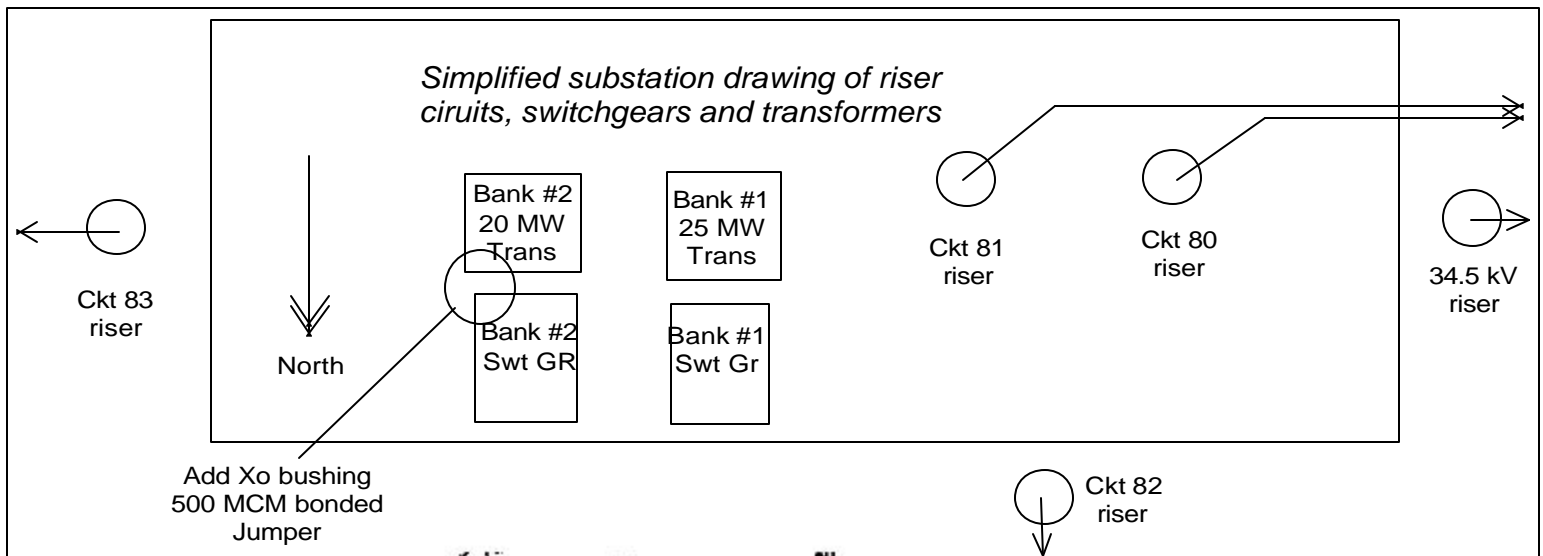
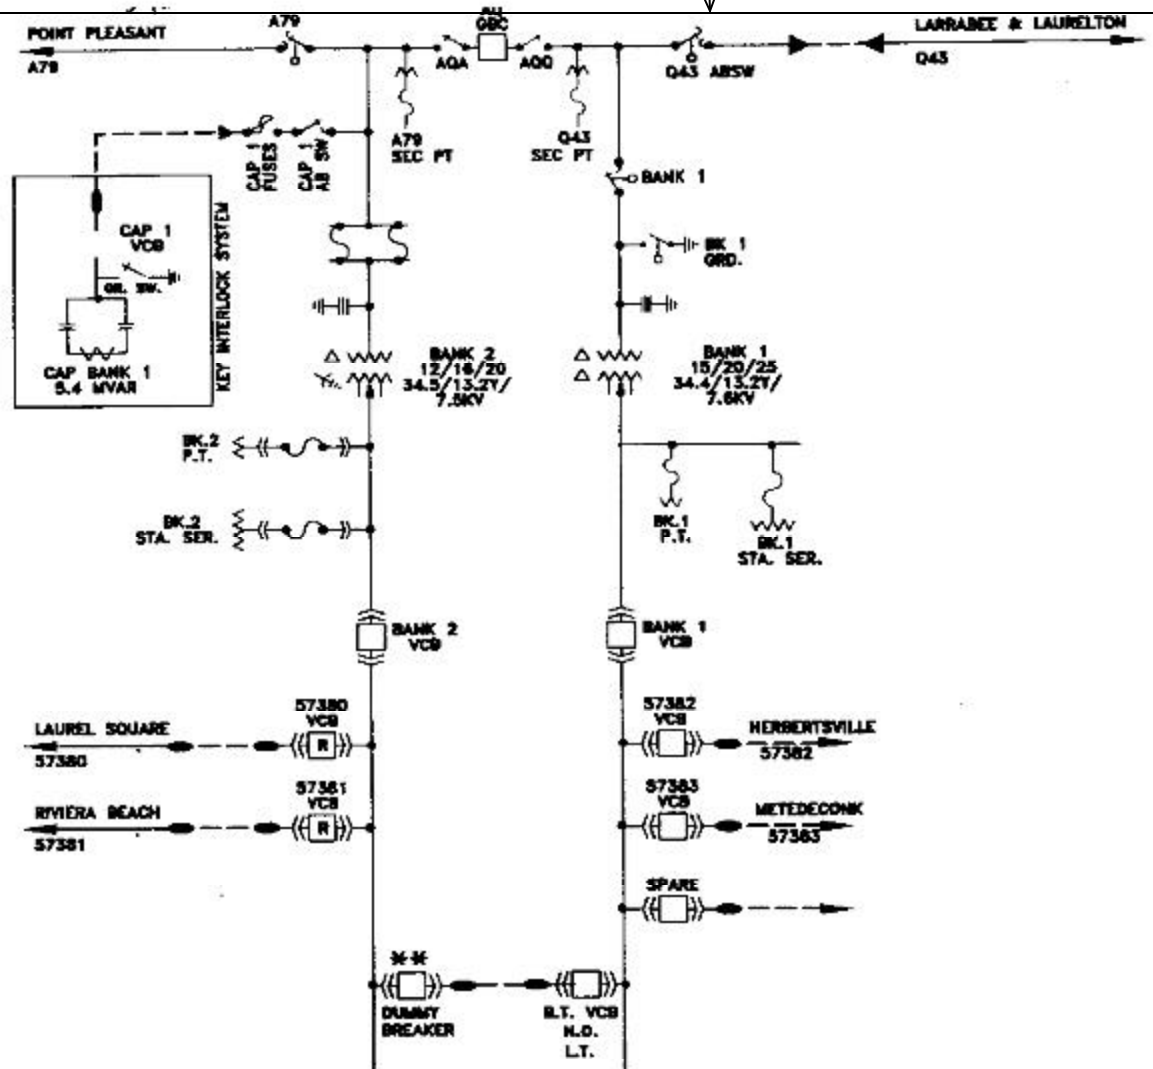
Figure #1, Herbertsville Substation Single Line Diagram

Two overhead 34.5 kV sub-transmission lines supply two delta-wye transformers in the Herbertsville substation as shown in *Figure #1, Herbertsville Substation Single Line Diagram*. Bank #1 is a pad-mounted 25 MVA transformer (34.5 kV-12.5 kV) connected via a sealed busway to an enclosed switchgear supplying circuits 82 and 83. Bank #2 is a pad-mounted 20 MVA transformer (34.5 kV-12.5 kV) connected via three exposed phases to insulated taps of an enclosed switchgear supplying circuits 80 and 81. Before April 2002, Bank 1 and circuits 82 and 83 were a delta 4.8 kV distribution system (6.25 MVA) until upgraded to a 12.5 kV wye system. *The primary feeder circuits (Lines 80, 81, 82 and 83) use 397AA conductors from the riser poles out through each distribution circuit; however, the primary neutrals vary from 4CU to 2ACSR as indicated on the system drawings.*

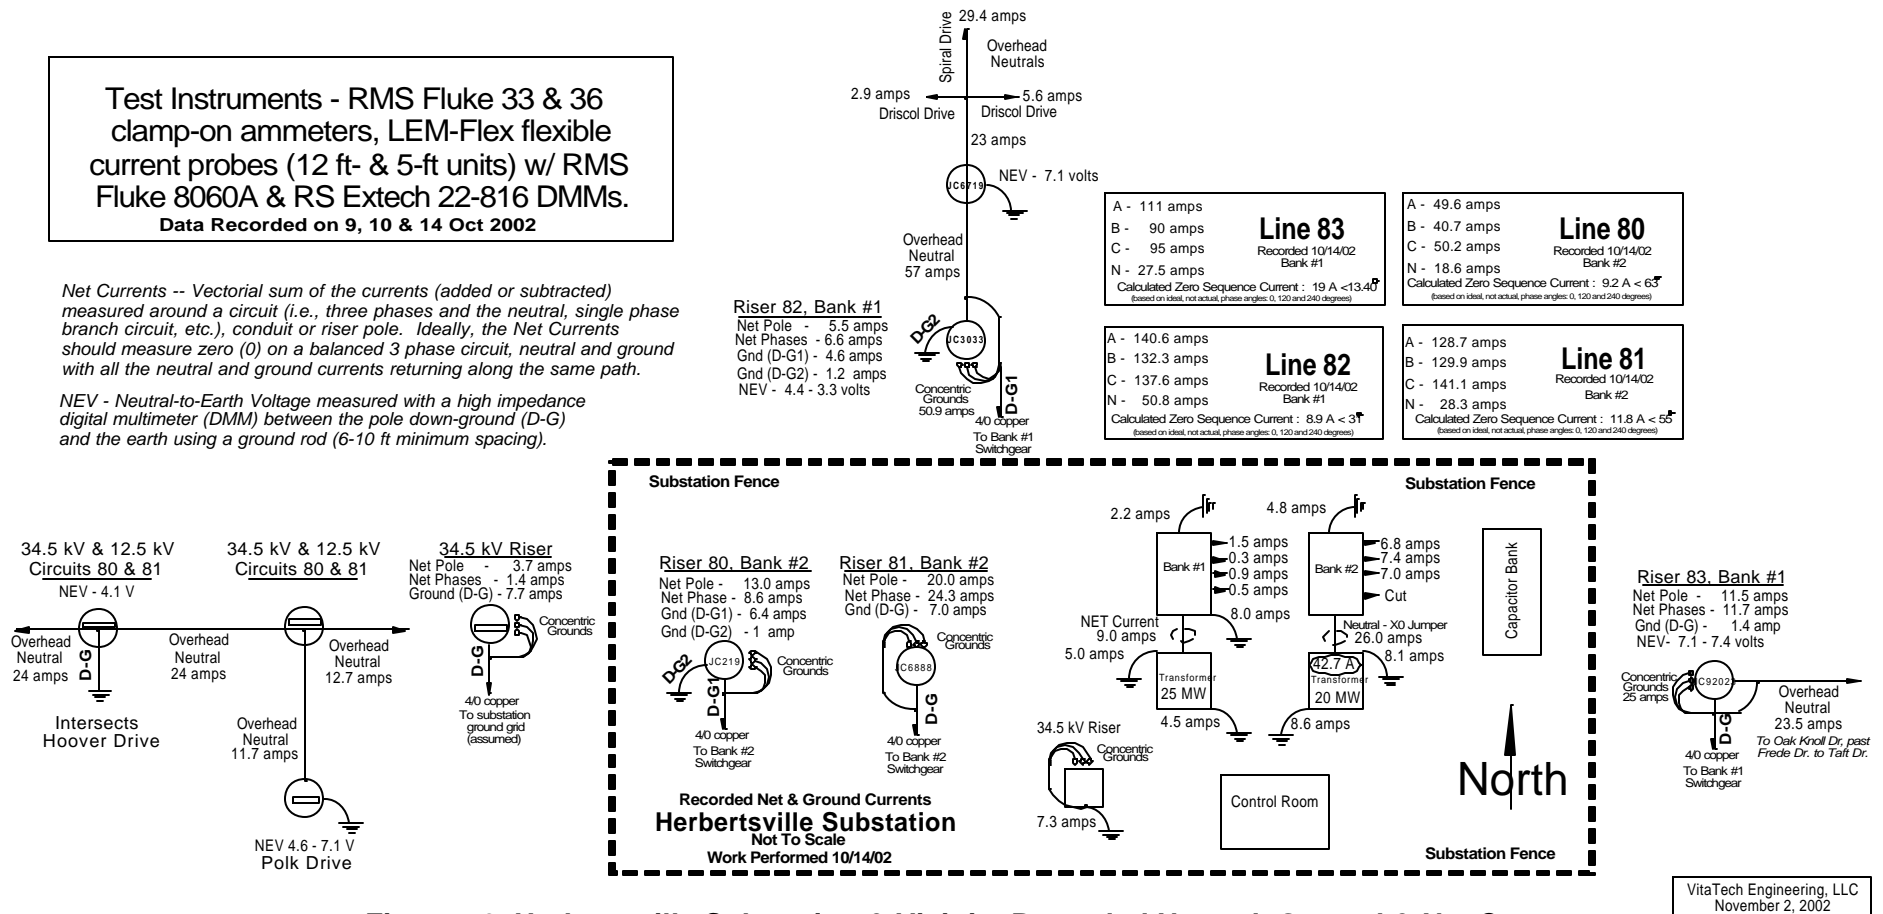
Figure #2, Herbertsville Substation & Vicinity Recorded Neutral, Ground & Net Currents

According to the data a significant proportion of the primary neutral current for Lines 80 and 81 returns to the Bank #2 transformer via the substation ground grid and grounding conductors. The switchgear ground wires (four total) of Bank #2 sum to 26 amps – this current returns to the Xo bus of the transformer via a new 500 MCM jumper (recommended by VitaTech with negligible impact) as shown in *Figure #2, Herbertsville Substation & Vicinity Recorded Neutral, Ground & Net Currents*. Another 16.7 amps returns by the ground grid, summing the total to 42.7 amps that returns directly to the 20 MVA transformer wye. For risers 80 and 81, the combined net pole current was 33 amps ($13 + 20 = 33$) with 9.7 amps ($42.7 - 33 = 9.7$) returning

by another path (i.e., either neutrals on Lines 82 or 81). For Lines 80 and 81, a significant proportion of primary neutral current returns via the earth and other circuits (Lines 82 and 83) to the substation grid – not very good! This is the primary reason the substation grid-to-earth voltage is 9.3 V and earth-to-earth voltage 3.2 – 3.5 V in the adjacent Frede Park as shown in *Figure #3, Herbertsville Substation & Vicinity Recorded Neutral & Earth Voltages*. Magnetic flux density data recorded in milligauss (mG) on the ground inside the substation shows elevated levels along the south fence in Figures #6, #7 and #8. Figure #7 was included to verify higher levels were recorded on the ground rather than at 1-meter along the south fence. Earth currents from Lines 80 and 81 appear to return on the south side of the grounding grid because of the elevated magnetic emissions, which is bonded to the substation fence.

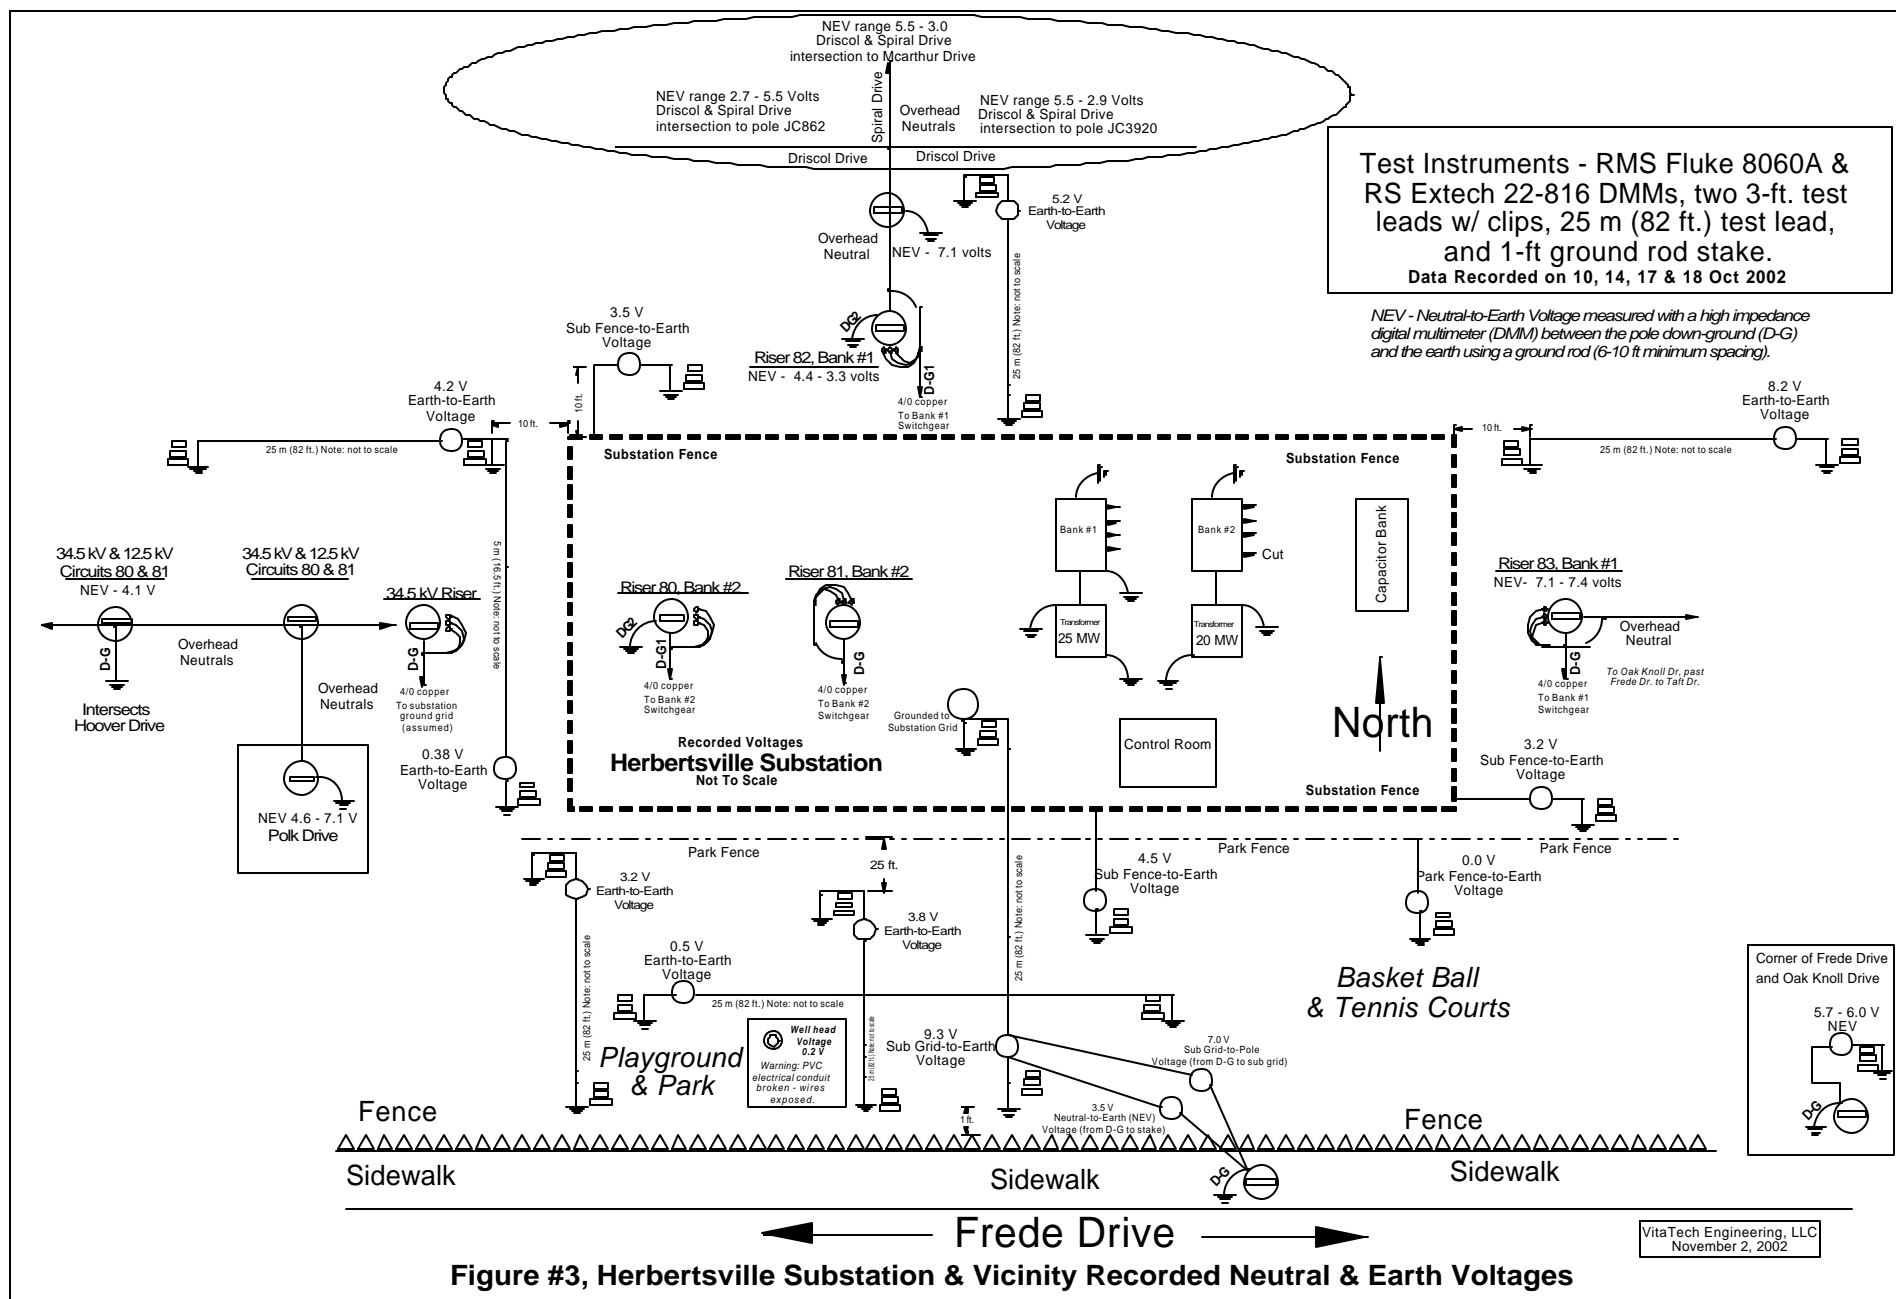
Figure #3, Herbertsville Substation & Vicinity Recorded Neutral & Earth Voltages

The three actions reduced the neutral-to-earth voltages (NEV) on the down-grounds from 10 V to 5 V on Driscoll Drive, Spiral Drive and McArthur Drive and Riser 82. On several occasions VitaTech recorded neutral-to-earth voltages (NEV) around Driscoll Drive and other locations around the system as shown in *Figure #5, Neighborhood Neutral-To-Earth (NEV) Voltages & Harmonics*. It should be noted that higher NEV levels (4-8 Volts) remained along Line 83 from the riser pole, along the east service road, south on Oak Knoll Drive to the intersection of Frede and west on Taft Avenue and beyond. The NEV levels (and stray voltage problems) at the down-grounds of Lines 80, 81, 82 and 83 and the substation grid will proportionally increase

Simply stated, in a typical well-balanced distribution system (less than 10% unbalanced phases), the primary neutral currents from the distribution transformers return to the substation via two paths: low-impedance, properly sized, primary neutral conductors and the multi-grounded neutral (MGN) system that injects primary currents into earth (assuming low soil resistivity and/or high water table) which in turn flow via conducting earth channels (i.e., adjacent to water mains or sewers, in underground streams and water tables, between layers of slate, etc.) back to the substation ground grid. If the soil has high resistance around the substation (this is the case at the Herbertsville substation and adjacent neighborhoods according to the NJGS report), then the earth currents must return through the MGN down-grounds incrementally adding current pole by pole to the neutral conductors, thereby increasing the neutral-to-earth voltage (NEV) and the earth-to-earth voltage in the areas around the substation and neighborhood as shown in *Figure #3, Herbertsville Substation & Vicinity Recorded Neutral & Earth Voltages* and *Figure #5, Neighborhood Neutral-To-Earth (NEV) Voltages & Harmonics*.

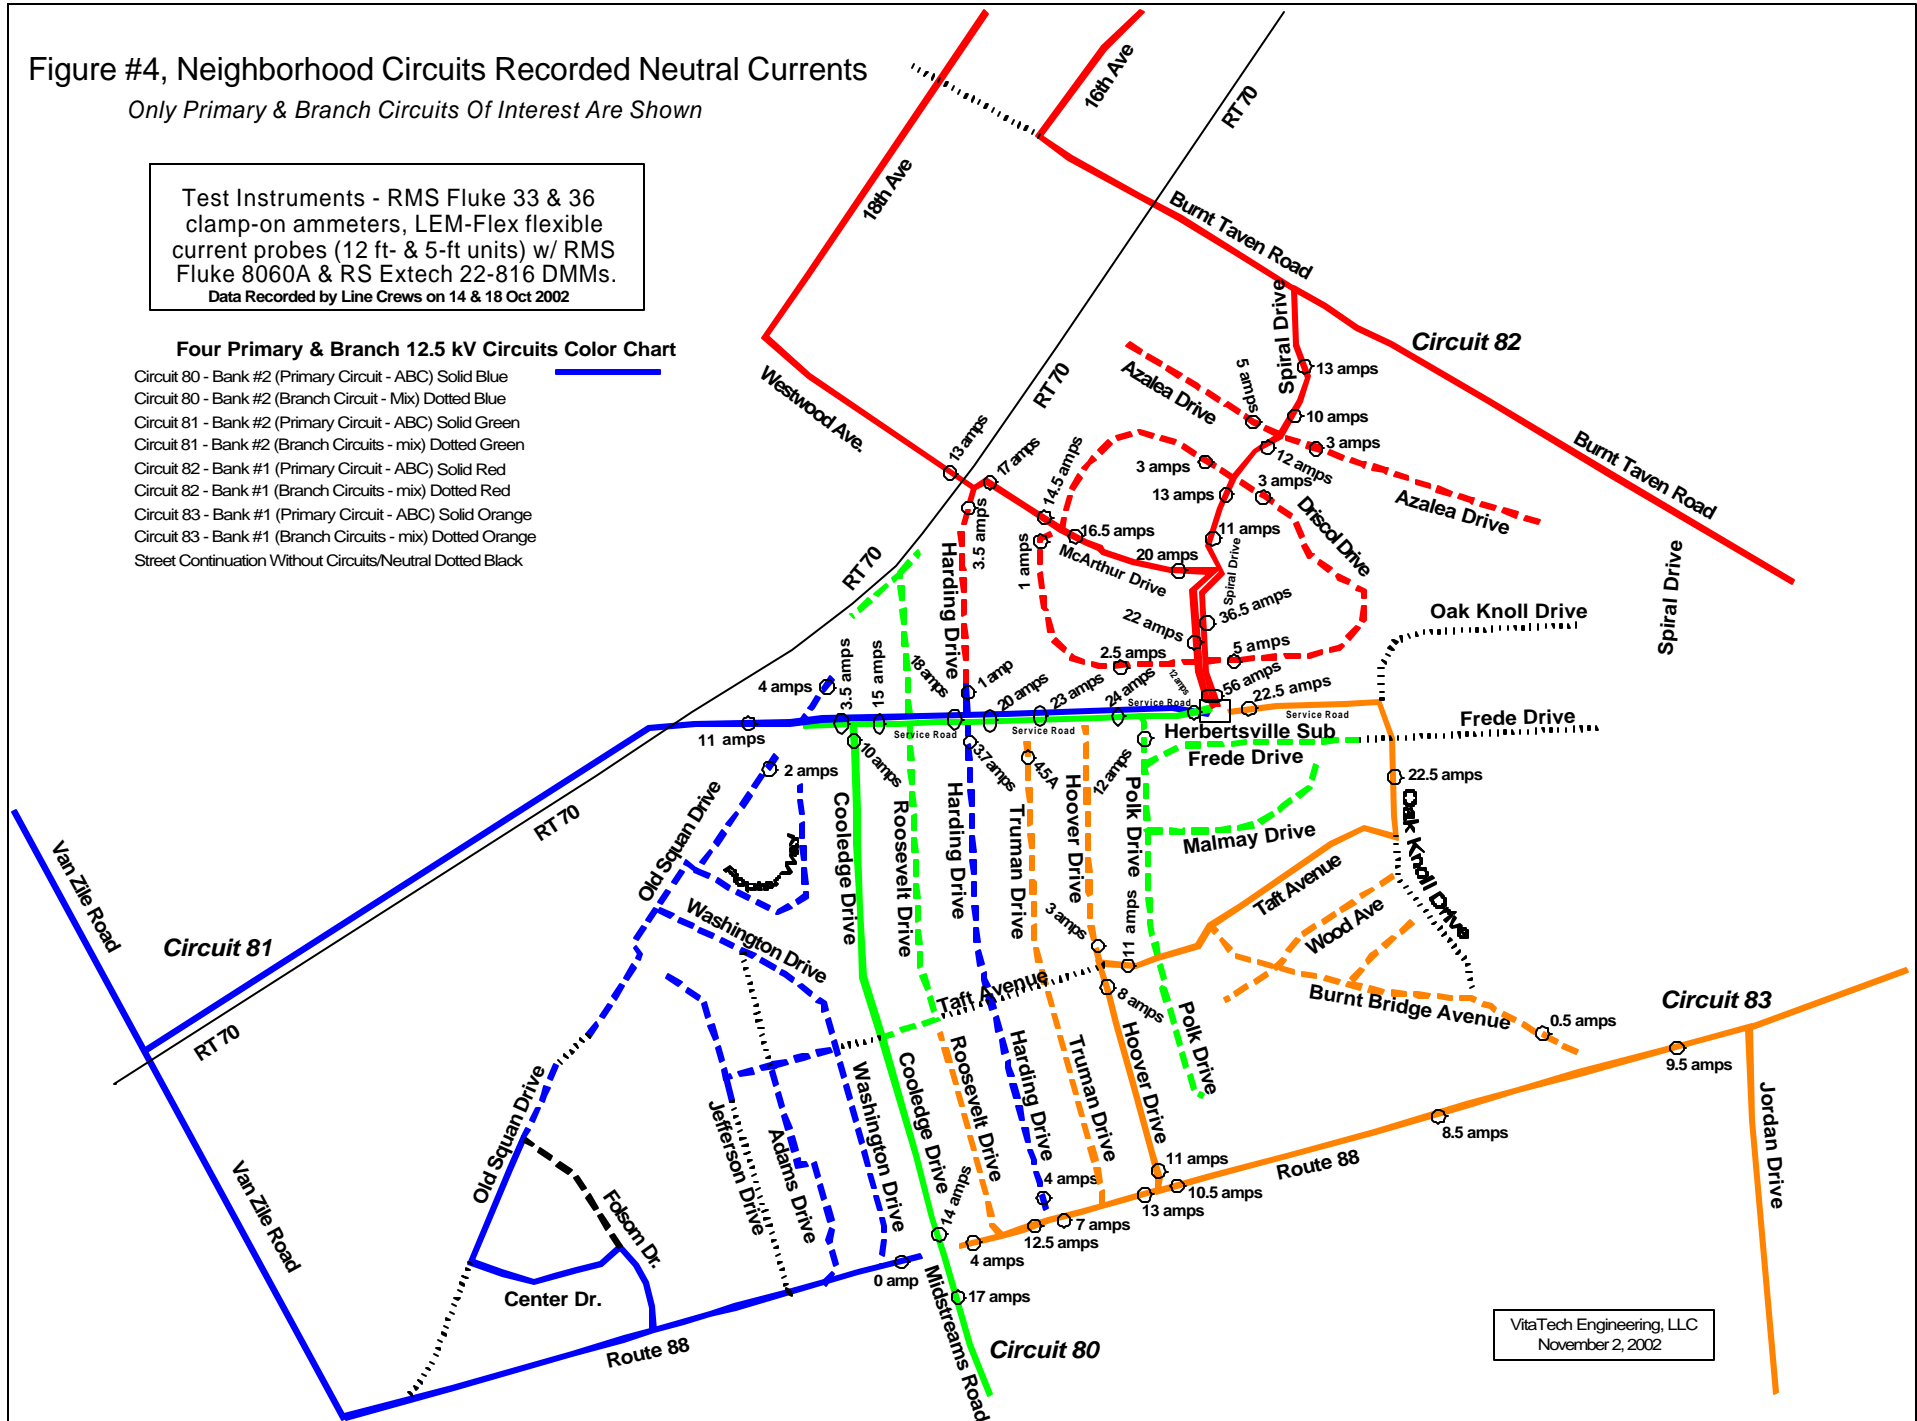
Figure #4, Neighborhood Circuits Recorded Neutral Currents

Primary neutral currents measured at selected locations and circuits are shown in *Figure #4, Neighborhood Circuits Recorded Neutral Currents*. The primary neutral of Line 82 had 56 amps at the riser pole and only 29.5 amps ($13 + 16.5 = 29.5$) at the intersections of Driscoll Drive with Spiral Drive and McArthur Drive. Where did the additional 26.5 amps come from? The larger customer load on Line 82 is north and west of the Driscoll area and a portion of the primary neutral return current must be returning as earth currents. Examining the magnetic field harmonic spectrum data in *Figure #5, Neighborhood Neutral-To-Earth (NEV) Voltages & Harmonics* may elucidate this concept. Third harmonic currents returning up through the MGN down-grounds generate higher 3rd harmonic magnetic emissions moving south on Spiral Drive from Burnt Tavern Road to the substation. Why is this Line 82 current? Look at *Figure #2, Herbertsville Substation & Vicinity Recorded Neutral, Ground & Net Currents*, the net pole Riser 82 current is only 5.5 amps (this is the current not returning via Riser 82 neutrals and grounds). So, nearly all 26.5 amps (the balance of 56 amps – 29.6 amps) is from the larger customer load of Line 82 west of the Driscoll area. These returning earth currents are migrating up the down-grounds and raising the Neutral-to-Earth Voltage (NEV) and the Earth-to-Earth voltage in the neighborhood adjacent to the substation. Remember, the primary neutral return current is a sum of the harmonic (3rd, 5th, 7th, 9th, 11th, 13th, 15th, etc.) components, especially the triplen harmonics, which are due to the zero-sequence currents of the unbalanced phases. *Therefore, decreasing the harmonic content on the primary neutrals (not an easy task) will concurrently reduce the neutral-to-earth voltage (NEV) on the down-grounds, substation grid and earth-to-earth voltages around the substation and adjacent neighborhood.*

The Line 83 primary neutral currents is 22.5 amps at the riser pole, along the east service road, and south on Oak Knoll Drive until the intersection of Taft Avenue and Hoover Drive where 11 amps suddenly diverts north down Polk Drive as shown in *Figure #4, Neighborhood Circuits Recorded Neutral Currents*. The Riser 83 net pole current is 11.5 amps as shown in *Figure #2, Herbertsville Substation & Vicinity Recorded Neutral, Ground & Net Currents*, which indicates 11.5 amps of the 22.5 amps of primary neutral current is probably from Lines 80 and 81. The primary neutral current is 24 amps on Lines 80 and 81 west of Polk Drive, which share a single primary neutral, then the current divides where the Polk Drive neutral bonds to the Line 80 and 81 neutral: 12 amps continues east to the substation and 12 amps travels south down Polk Drive to Taft Avenue adding to the 11 amps from the Hoover Drive primary neutral (Route 88 and Jordan Drive areas) for a total of 23 amps, which is the total at Riser 83, along Oak Knoll and Taft Avenue. The Neutral-to-Earth Voltage (NEV) ranged from 5.7 – 6 V on the corner of Frede Drive and Oak Knoll Drive as shown in *Figure #3, Herbertsville Substation & Vicinity Recorded Neutral & Earth Voltages*. The additional primary neutral current is responsible for the elevated Neutral-to-Earth Voltages (NEV) at the Frede and Oak Knoll intersection. Primary neutral currents from Lines 80 and 81 are returning to the substation via the Polk Drive, Taft, Oak Knoll neutrals of Line 83. Needless to say, this clearly demonstrates the complexity of assessing stray current problems associated with return primary neutral and earth currents.

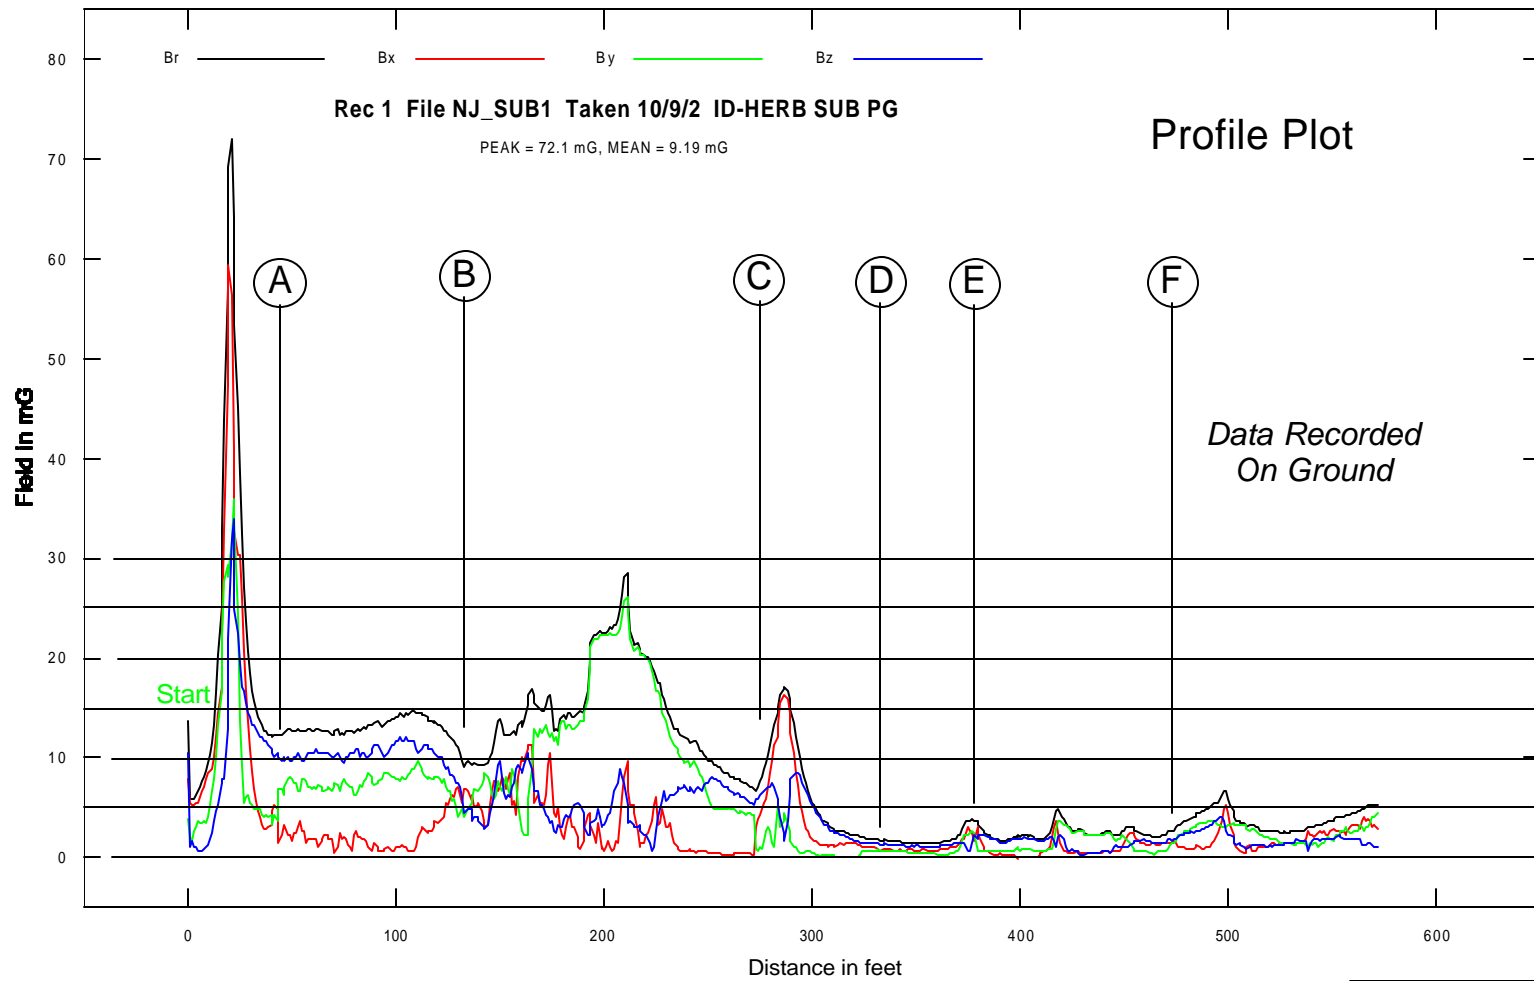
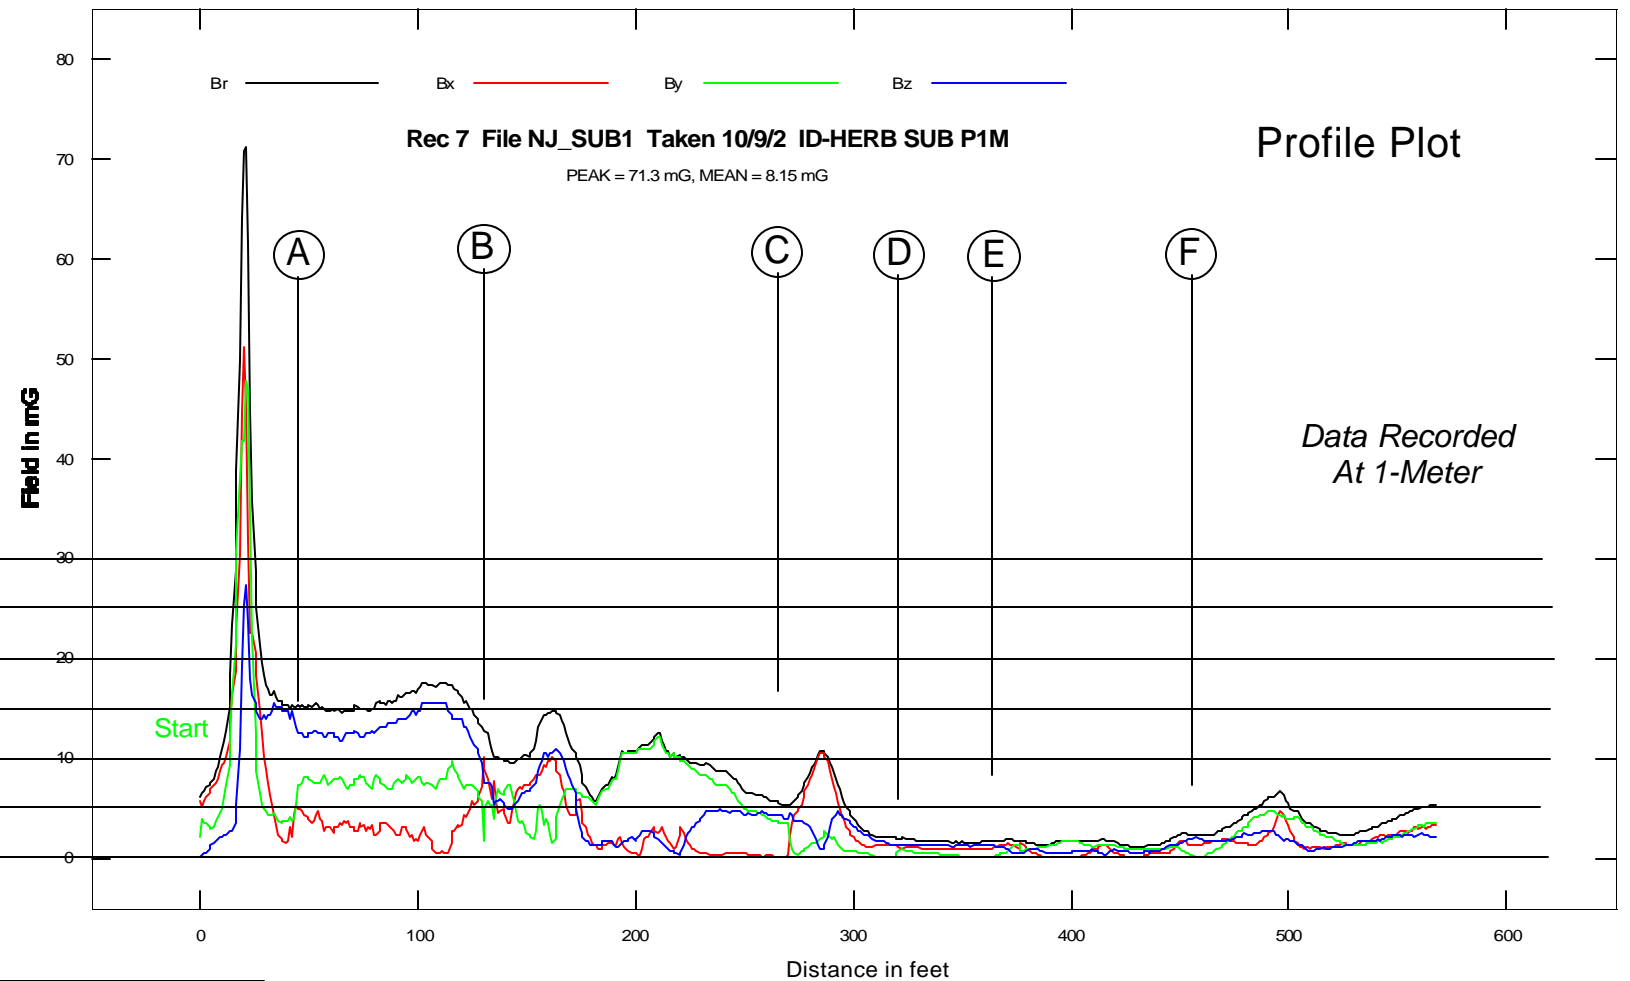
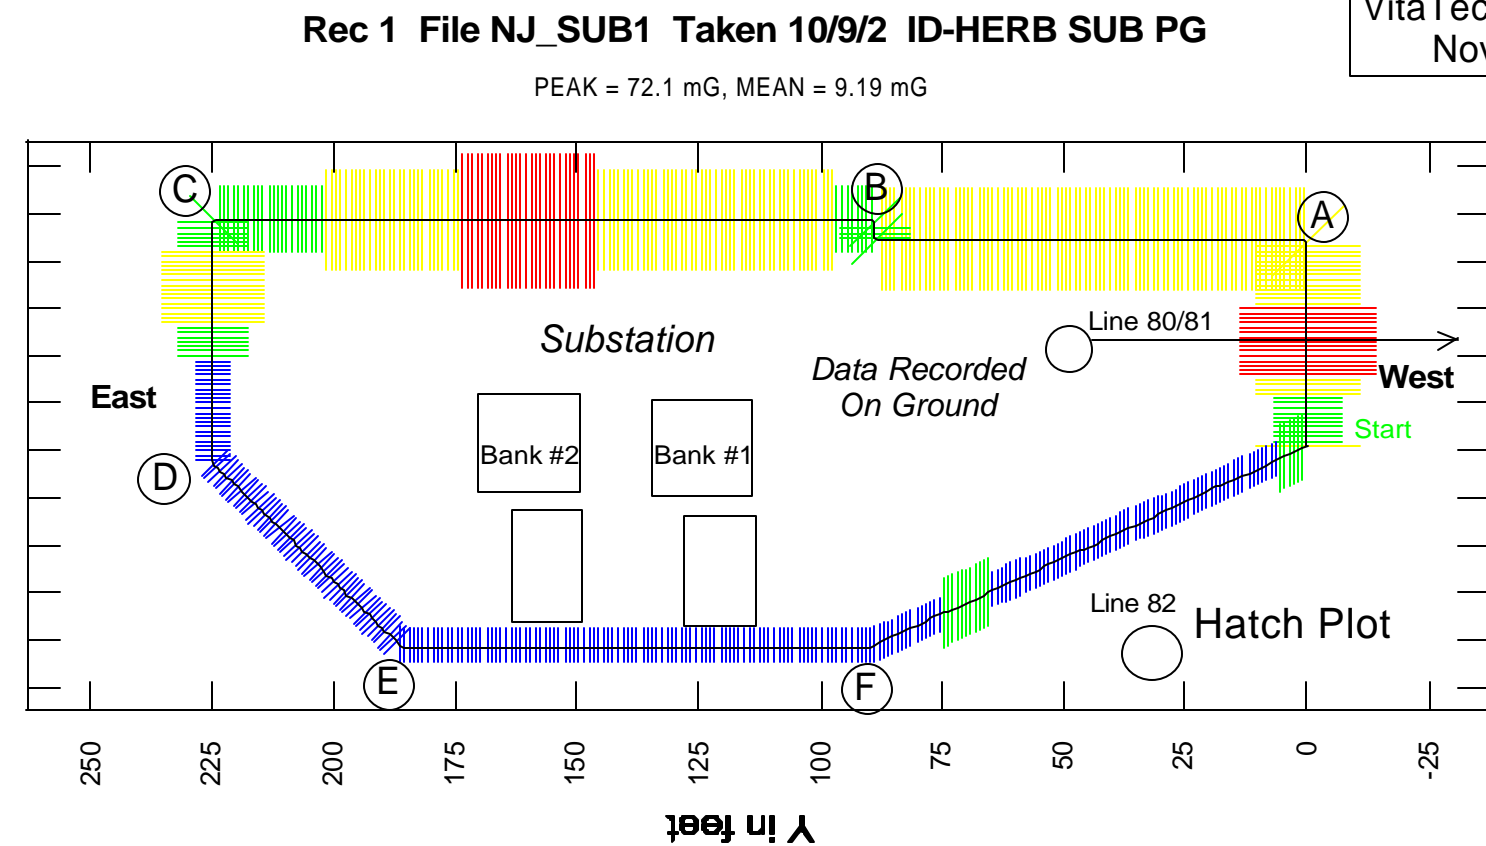
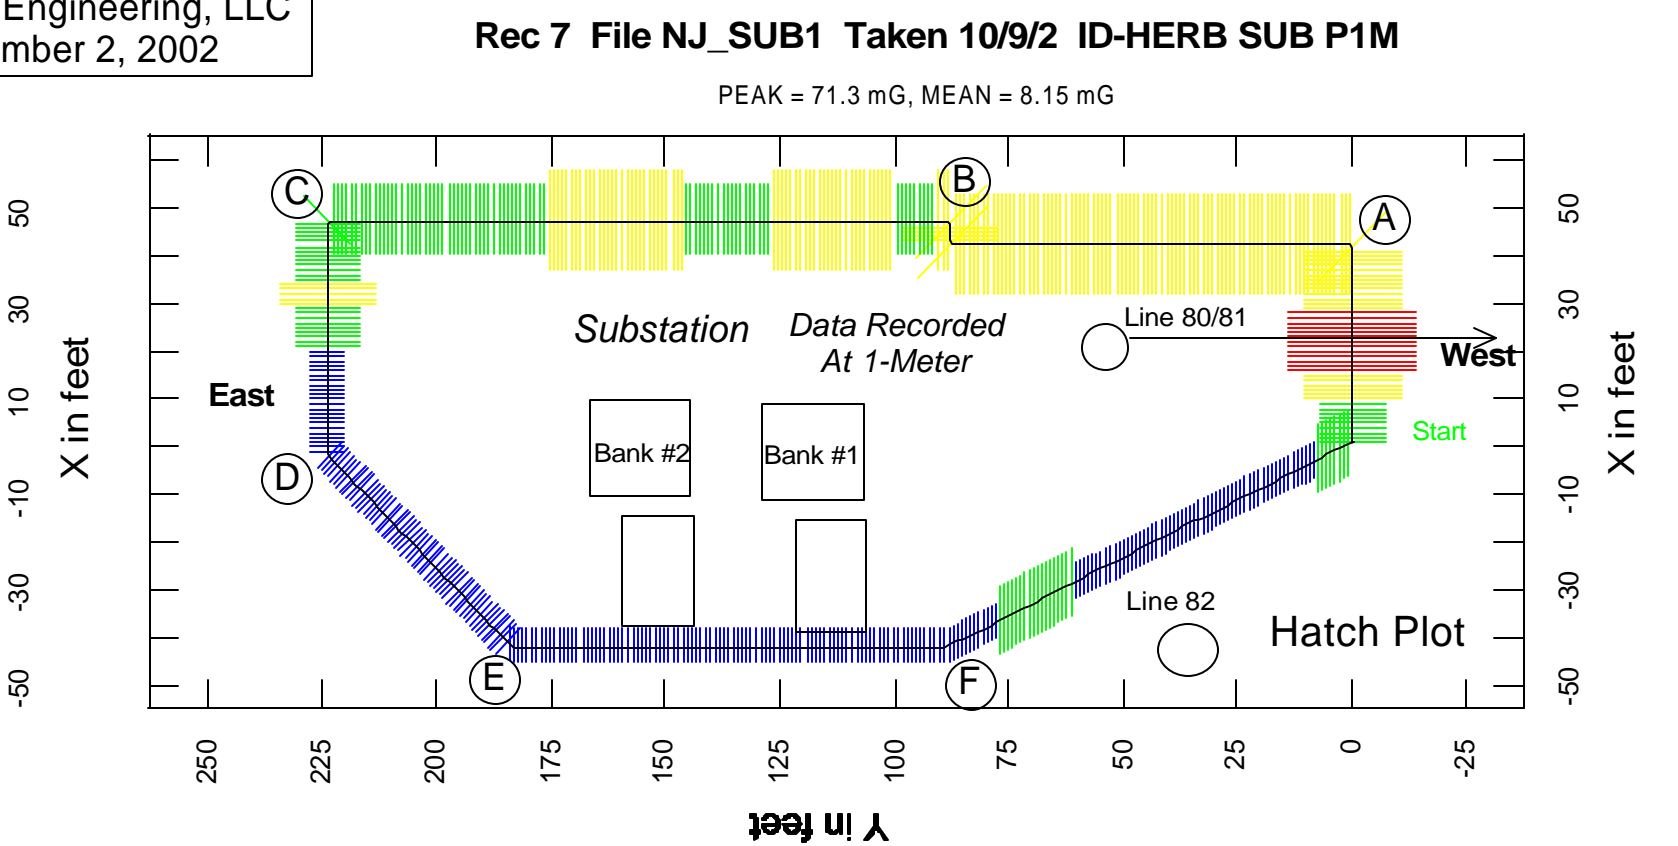
**Figure #6, Herbertsville Substation Magnetic Flux Density Data
Perimeter Hatch & Profile Plots At Ground & 1-meter Levels**

PEAK = 72.1 mG, MEAN = 9.19 mG

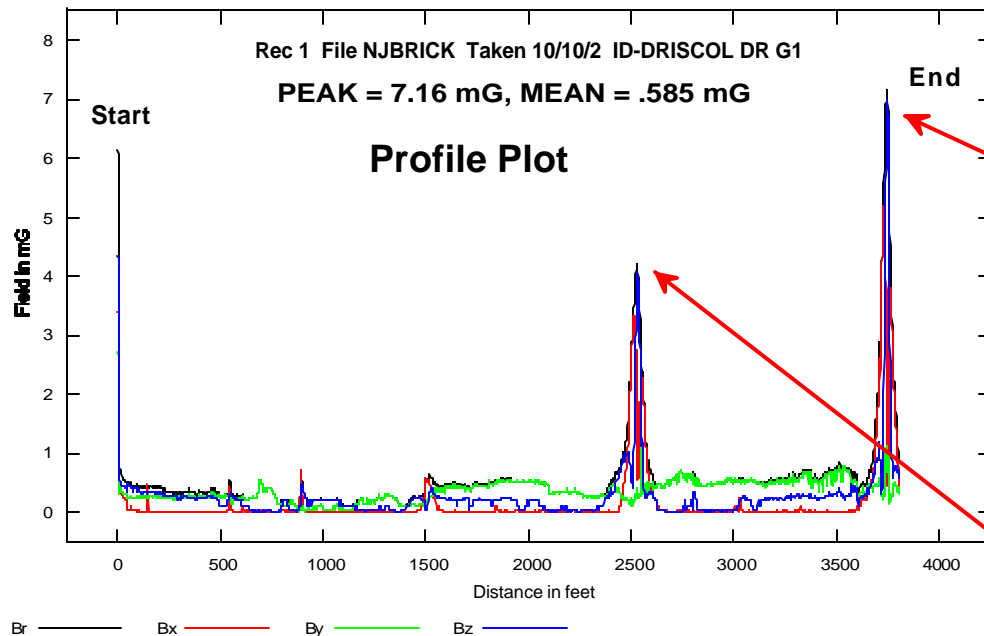
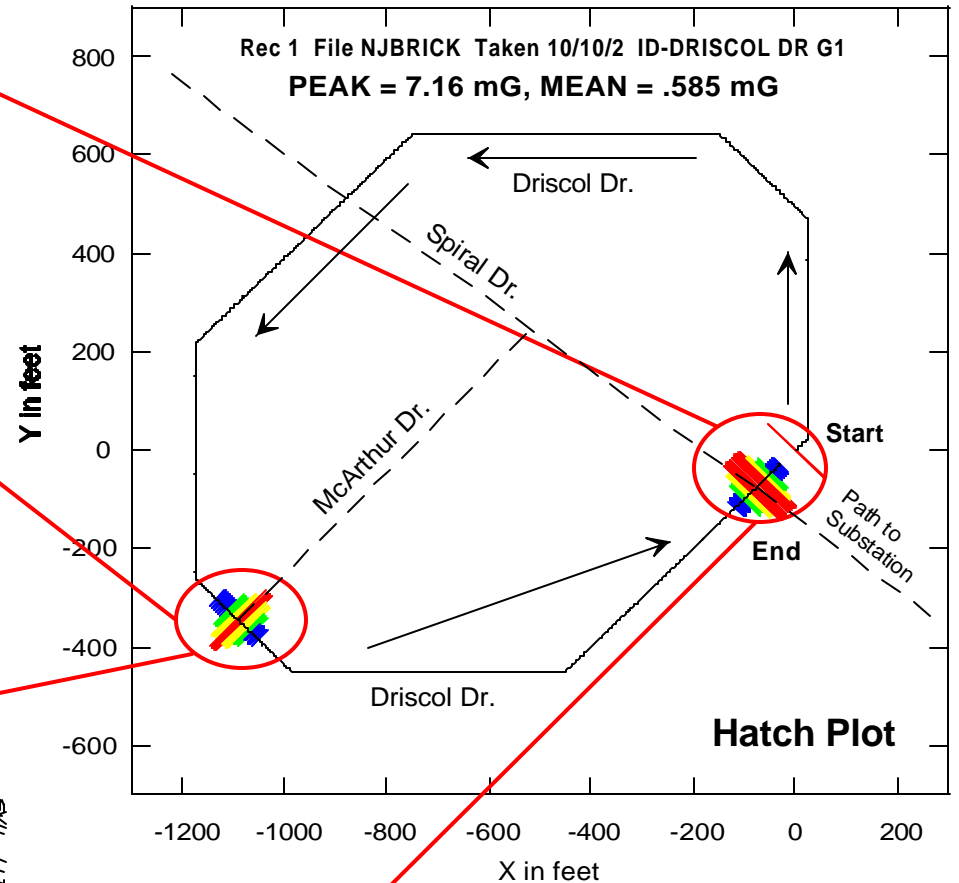
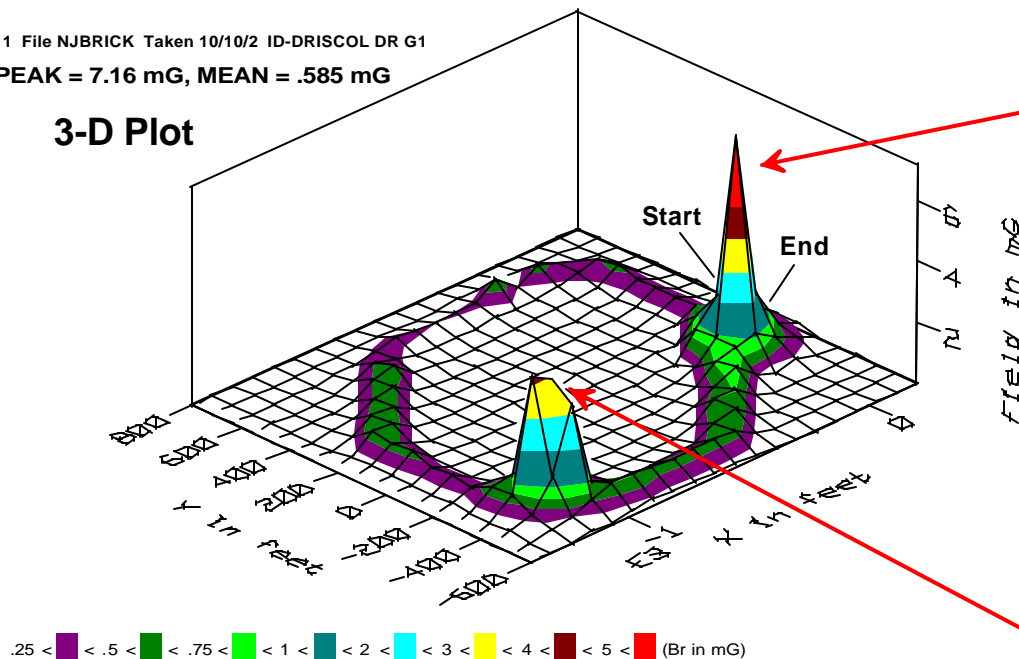
Figure #9 - Driscoll Drive Magnetic Flux Density Data October 10, 2002
Hatch, Profile & 3-D Plots Recorded at Ground Level

Rec 1 File NJBRICK Taken 10/10/2 ID-DRISCOL DR G1
PEAK = 7.16 mG, MEAN = .585 mG

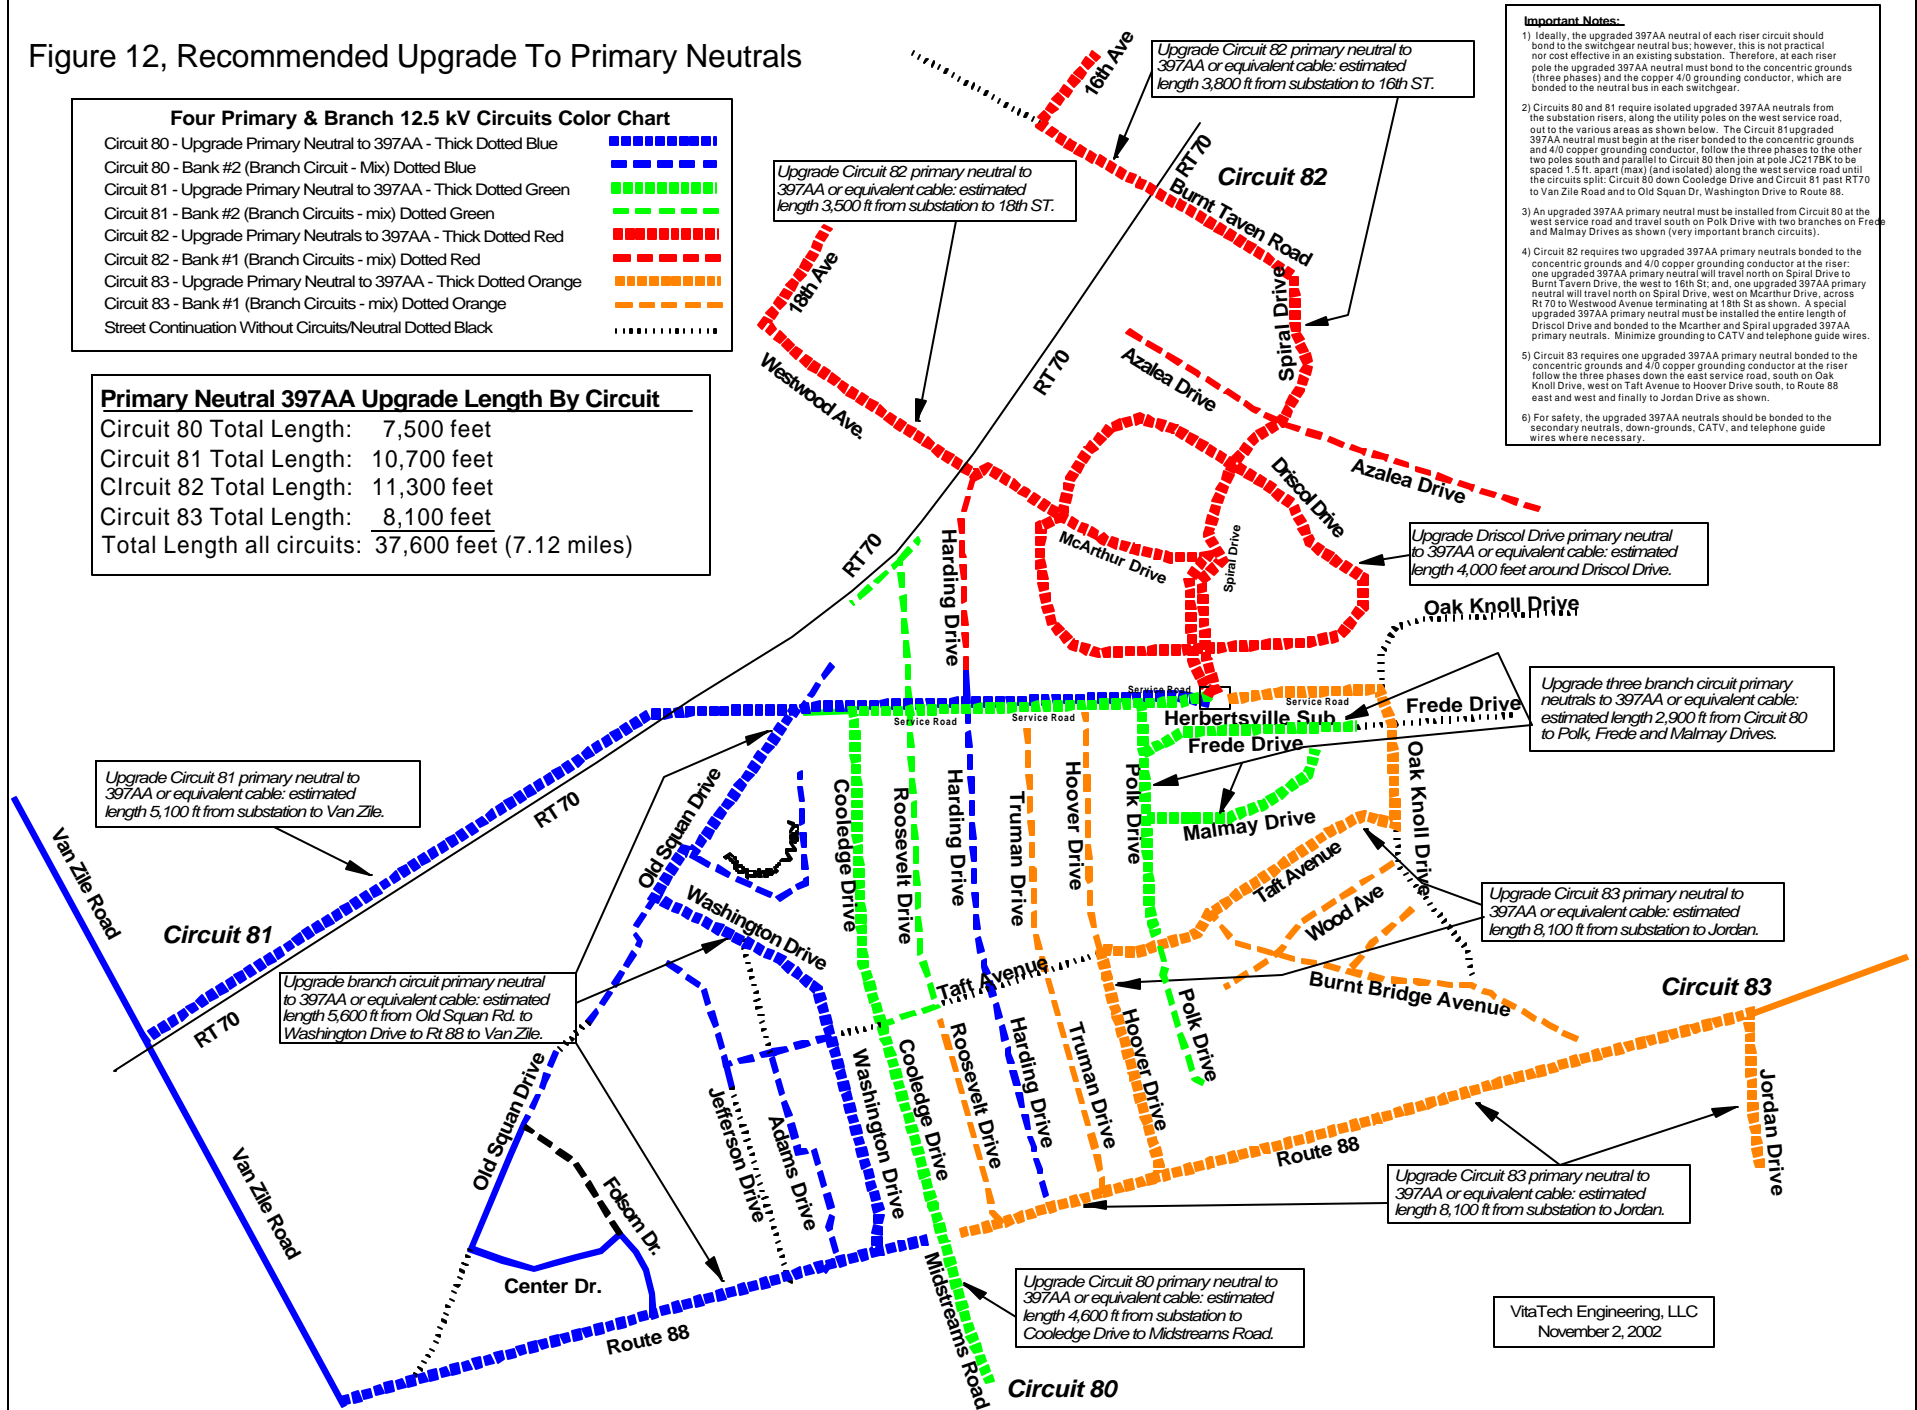
Figure 12, Recommended Upgrade To Primary Neutrals

1. Primary neutrals on Lines 80, 81, 82 and 83 not sized to accommodate soil and exceptional Summer 2002 drought conditions.
2. Poor soil conditions and low water table (saturation zone) at the Herbertsville substation and four distribution areas – impedes earth return currents traveling

3. Unbalanced phases exceeding 10% on Lines 80, 81, 82 and 83 during average load conditions -- could approach 20-25% during summer peak loads.

with the seasonal current loads and changes in soil resistivity (simply stated - the dryer the soil the higher the NEV problem). Therefore, next summer the stray current problems will reappear, especially if there is another drought (the severity is dependant on the weather and soil conditions) unless the primary neutral conductors are upgraded (increased wire size) to be equal to the 397AA phases as shown in *Figure #12, Recommended Upgrade To Primary Neutrals*.

1. Oversize primary neutrals on Lines 80, 81, 82 and 83 as specified in *Figure #12, Recommended Upgrade To Primary Neutrals* to match the size and impedance of the 397AA phase conductors. A total of 37,600 feet (7.12 miles) of upgraded 397AA primary neutrals are recommended to mitigate the stray voltage problem and achieve a neutral-to-earth voltage of 4-5 volts during summer months on the substation grid and down-grounds of the adjacent neighborhoods during peak summer loads. Specific routes and circuit length details for the recommended upgraded primary neutrals are provided in Figure #12; however, selected lateral circuits may also require upgraded 397AA neutrals to achieve the 4-5 volt summer performance objective including: Azalea Drive, Truman Drive, Harding Drive, Roosevelt Drive and Old Squan Drive.
